Home Inspection Report

Your adress

Your town

08/09/12

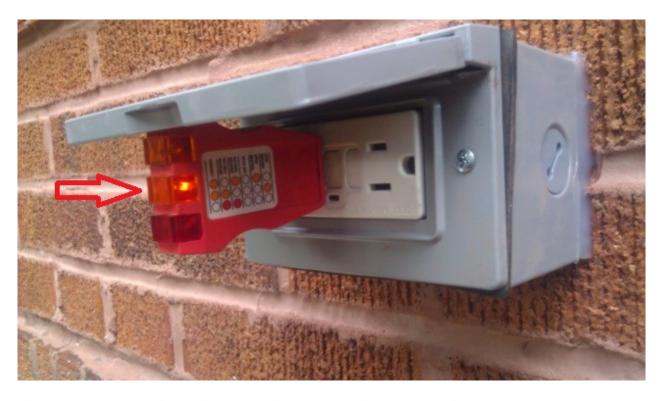
The exterior GFCI outlet on the West side is miss wired (open ground)

- 2. The exterior GFCI outlet on the West side is miss wired (open ground). The main electrical panel needs cleanup. A licensed electrician should evaluate and make all necessary corrections before closing.

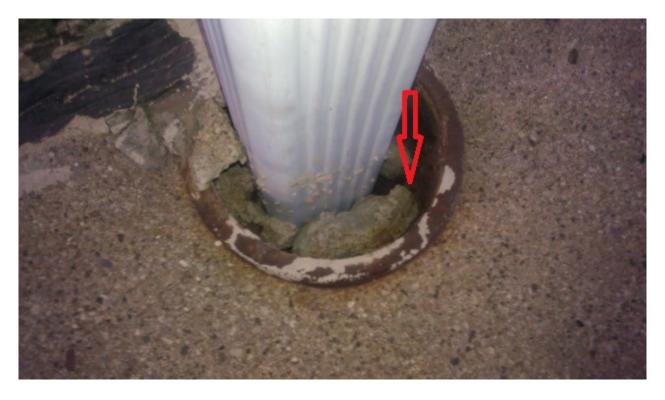
The drain tile opening on the South side should be sealed to avoid clogging.

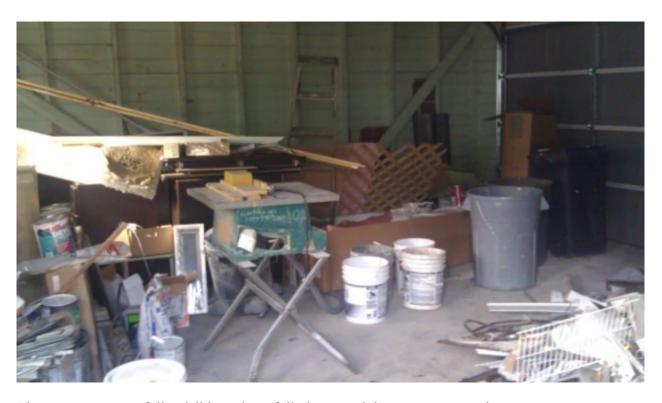
The garage was not fully visible and not fully inspected due to storage or clutter.

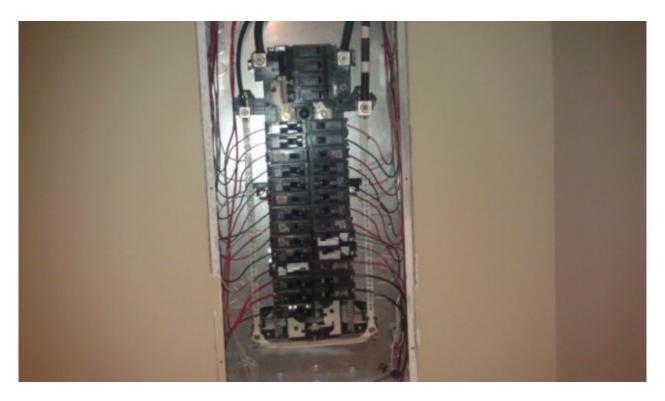
Issues: See summary page

The Electrical System, all or in part, needs professional evaluation prior to closing.

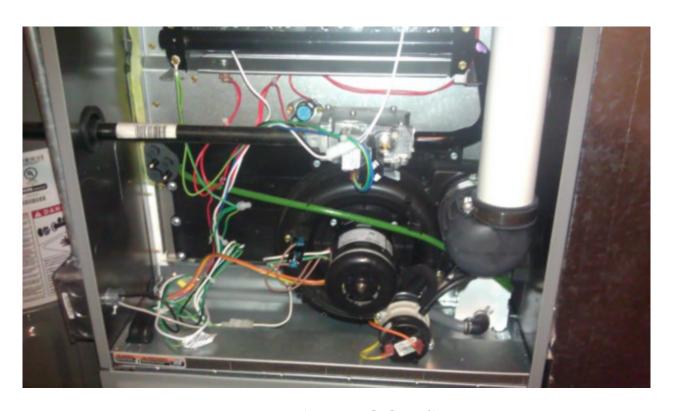
Gas to the home is shut off and no tests were done.

Is shut down

This HVAC system is in need of professional servicing and cleaning prior to the closing

The heat exchanger should be checked for cracks no matter what age

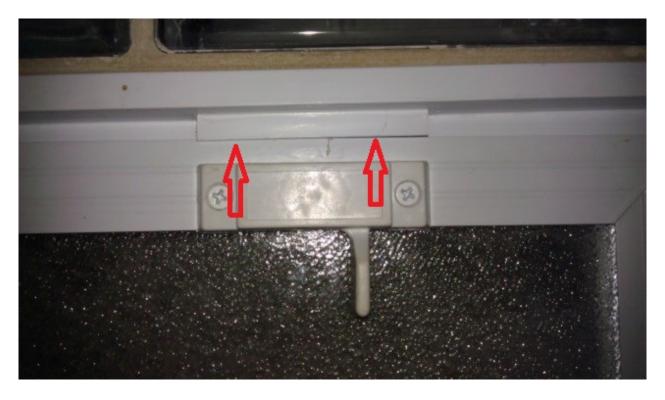
The basement bedroom window could not be opened.

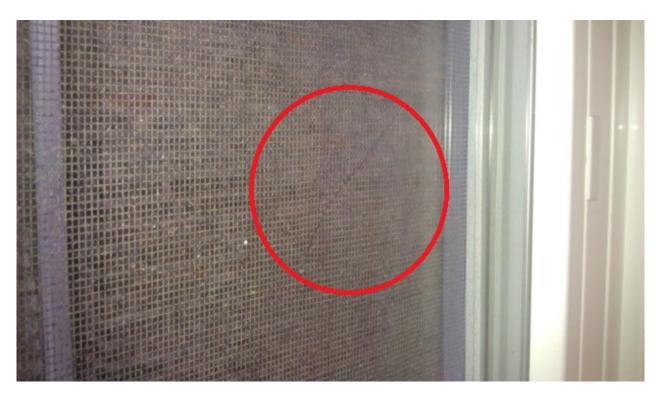
Living room window screen is damaged.

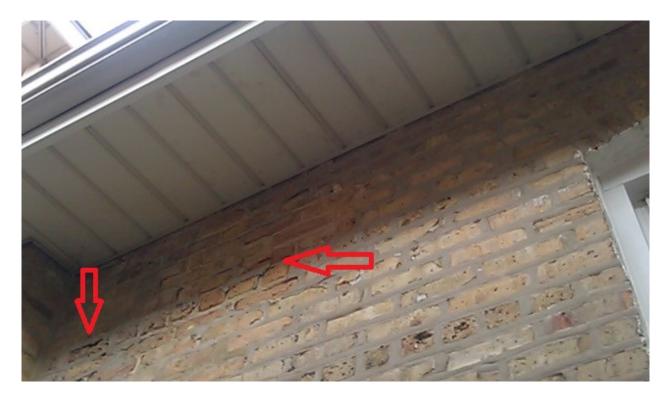
North side tuckpointing should be redone.

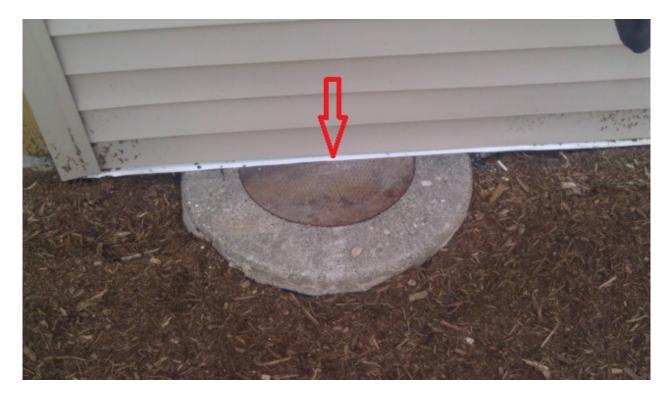
The exterior drain cleanout access is obstructed by the house siding.

- 3. The exterior drain cleanout access is obstructed by the house siding. The basement has no sump pump to protect it from water. The whirlpool in the master bathroom did not operate from the on/off switch button and the drain stop is defective. A licensed plumber should evaluate and make all necessary corrections prior closing.

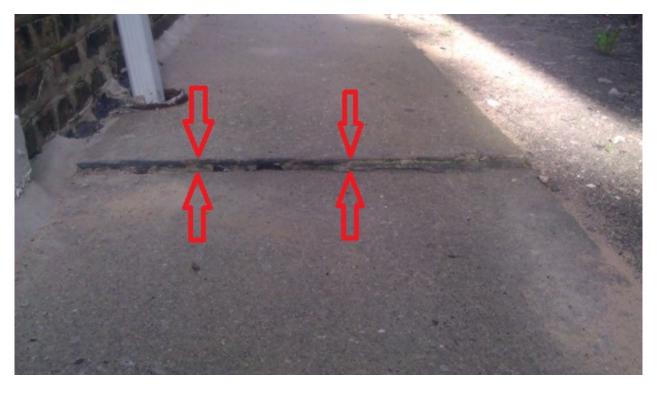
The South sidewalk has settled and is a trip hazard.

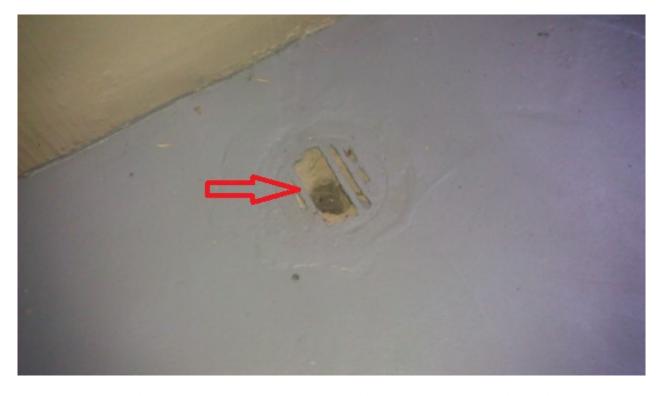
The exterior floor drain cover by the basement door is damaged and it should be replaced.

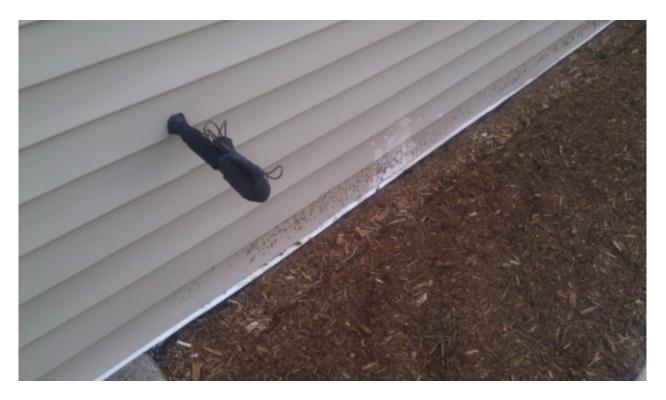
The AC condenser unit was not present or installed at the time of inspection.

- 1. The gas was off at the time of the inspection and all the gas appliances and components, including the furnace, could not be tested. The AC condenser unit was not present or installed at the time of inspection. The heating unit is in need of service and evaluation by a HVAC professional prior to closing.
